UNIVERSITY OF EXTRICATION

Subaru Ring-Shaped Reinforcement Frame

- Subject:** Subaru Ring-Shaped Reinforcement Frame
Topic: Design and construction of Subaru Ring-Shaped Reinforcement Frame
Objective: Develop an action plan for extrication tasks requiring removal of select model Subaru B-pillars
Task: Describe the tools and techniques that could be used by your department to cut through or remove the B-pillar of a Subaru Impreza, WRX, WRX STi, Forester, Legacy, Outback or Baja model vehicle.

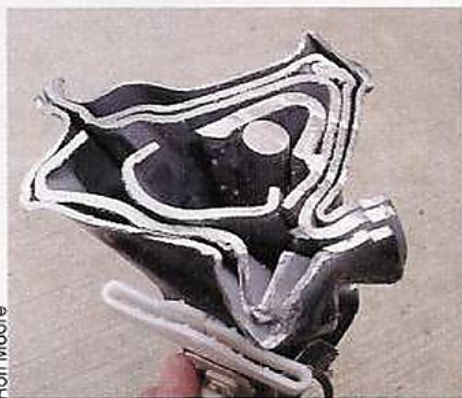
A cross-section view of the Subaru Forester B-pillar shows the eight layers of high-strength, high-tension steel, including the round steel rod running through the middle.

was eight layers thick! One of the layers of steel was a round steel rod that resembled a concrete rebar. That B-pillar had more layers of steel than I had ever seen before in a vehicle.

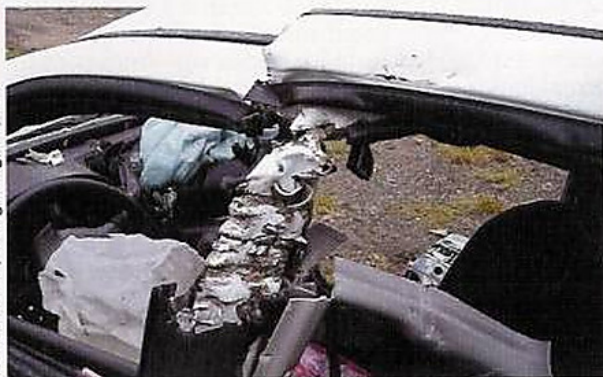
Both B-pillars on the Subaru WRX STi automobile resisted efforts to cut through it at the Orangeburg, NY, crash scene.

In September 2005, the Orangeburg, NY, Fire Department responded to an incident involving a four-door Subaru WRX STi. The Subaru collided with a Dodge minivan at an estimated speed of 75 miles per hour. The broadside impact required the rescue team

to remove the roof. The Subaru's A-pillars cut through quickly but the B-pillars again resisted every effort by the department to cut them.

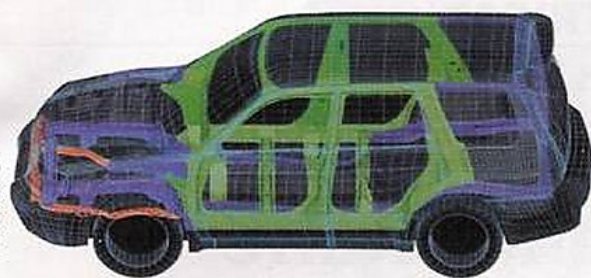
This artist's sketch uses the color green to identify the Subaru Ring-Shaped Reinforcement Frame on a Subaru Forester vehicle. The B-pillars are constructed of eight layers of exotic steel that resist common extrication cutting tools.

The Ring-Shaped Reinforcement Frame is part of a structural body construction in which body side panels and the pillars around them are connected and reinforced to form three rings. The A-pillars and the front firewall structure

make up one ring. Both B-pillars along with two structural frame members in the floorboard and two specially shaped structural mem-

bers running across the roof area make up the center ring. The third ring is formed by the C-pillars and a strengthened lower rocker sill area. This construction design resists collision failure quite well and maintains passenger compartment integrity by dispersing the impact of the crash away from the occupants.

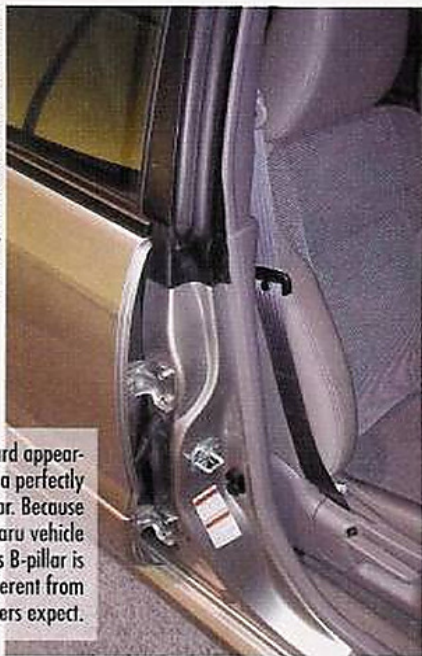
From all outward appearances, this is a perfectly normal B-pillar. Because this is a Subaru vehicle however, this B-pillar is uniquely different from what rescuers expect.

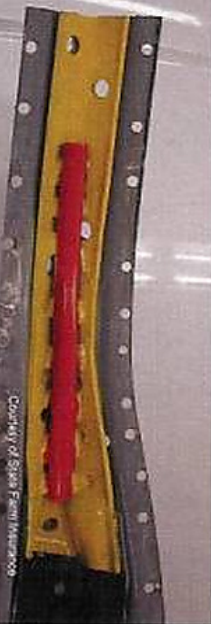
The B-pillar of a Subaru Forester has been removed from the vehicle and taken apart layer by layer. Paint colors have been used to illustrate the construction of this structural member for training purposes. Note the short length rebar rod, orange in color, mounted along the midsection of the pillar.

Not only is the metal in this area thick, it also has a round steel bar section in its core. Ironically, in both extrication case studies mentioned earlier, rescuers unknowingly attempted to cut the B-pillar at the point where it is intentionally the thickest and the strongest. The round rebar steel rod is only a little over 12 inches long and begins at the dashboard level and ends at almost the height of the roof rail. In this same middle portion of B-pillar there is also an extra layer of exotic metal steel added to the inside and the outside surfaces to further reinforce and strengthen the pillar.

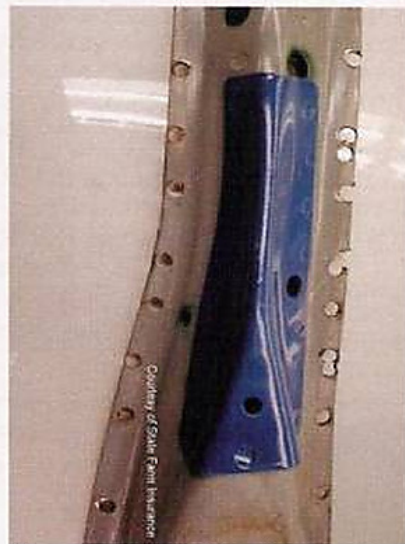
The opposite side of the Subaru Forester B-pillar clearly shows the additional high-strength, high-tension steel added at the mid point of the pillar. Blue paint has been added to enhance its visibility for training purposes. Note the location of the top door hinge mounting holes to better understand where this reinforcement is located in relation to the vehicle itself.
